Lockheed
Missiles & Space Company
Huntsville Research & Engineering Center

SPACE SHUTTLE MAIN ENGINE,
POWERHEAD STRUCTURAL MODELING,
STRESS AND FATIGUE LIFE ANALYSIS

VOLUME IV - SUMMARY OF INVESTIGATION
OF UNSCHEDULED EVENTS AND SPECIAL TASKS

December 1983

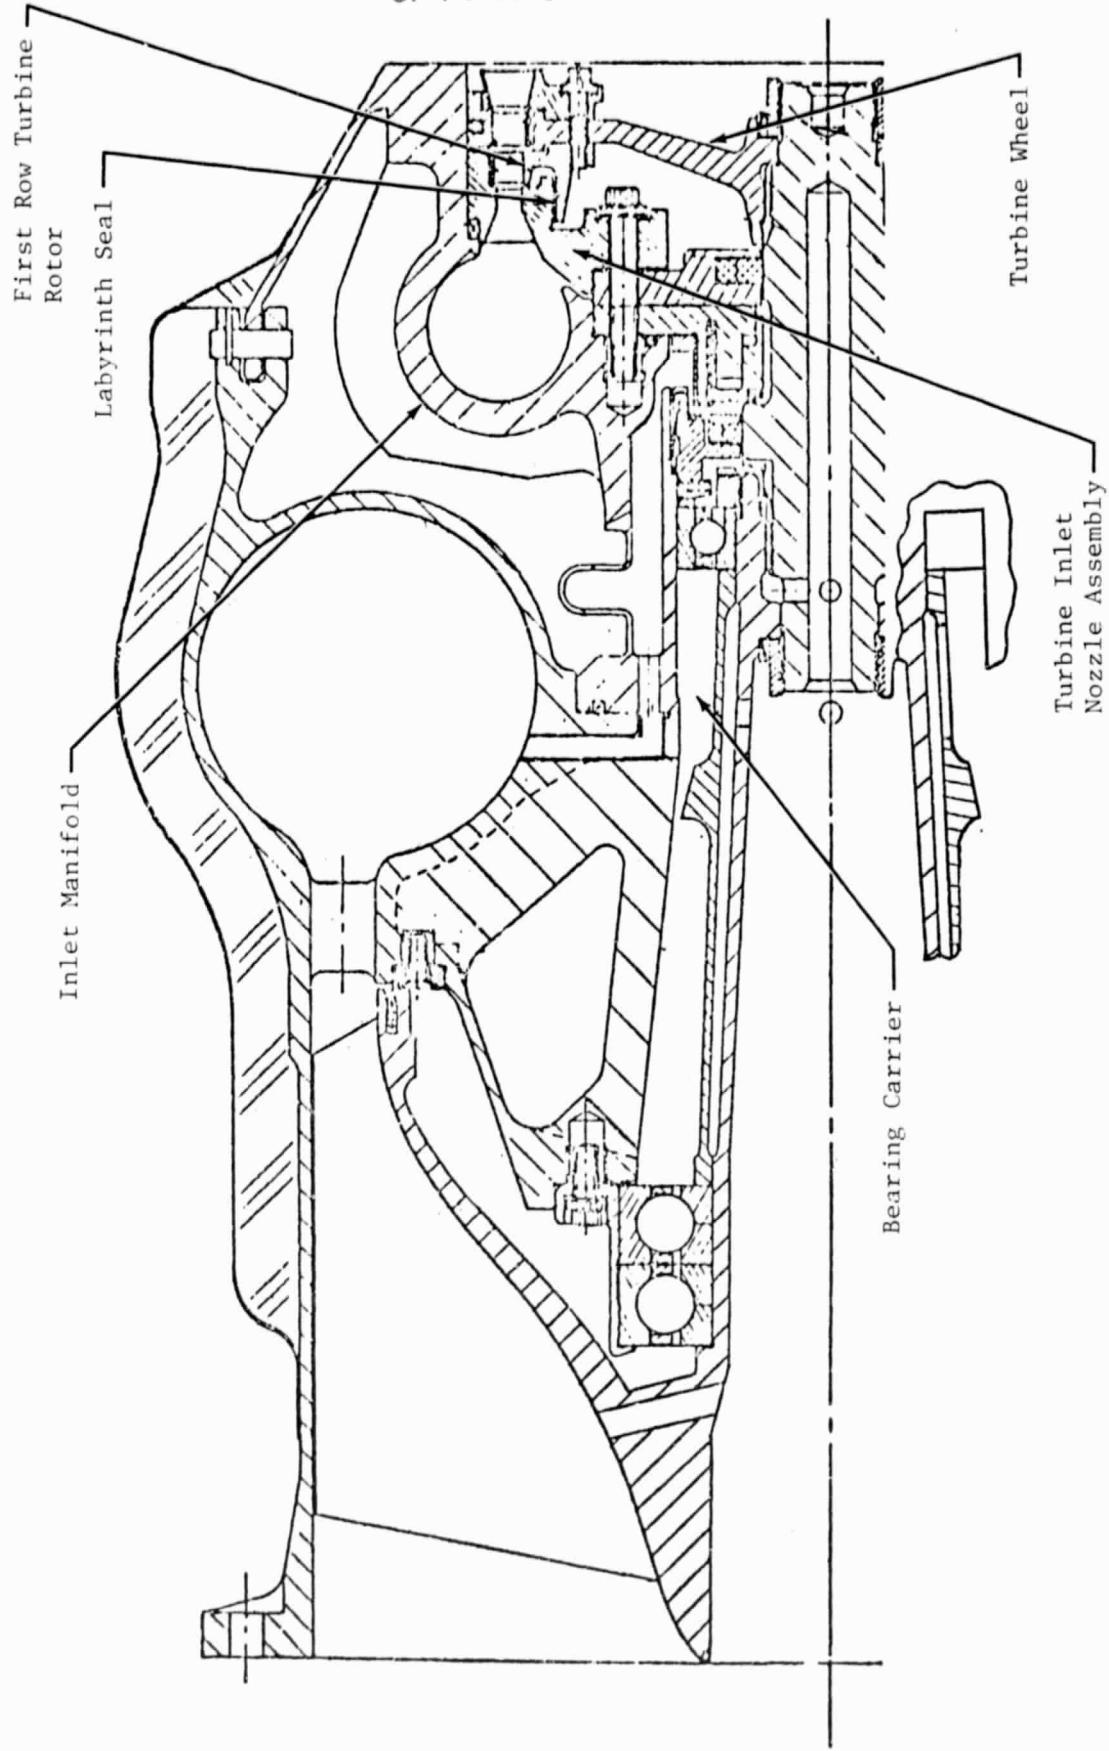
Fig. 2-1 Low Pressure Fuel Turbopump

Teardown examination of the Low Pressure Fuel Turbopump (LPFTP) has shown evidence of rubbing occurring between the turbine inlet nozzle assembly and the labyrinth seal located on the first row turbine rotor assembly (Fig. 2-1). The pattern of rubbing is not constant around the circumference of the nozzle-labyrinth seal interface, and changing the configuration of the nozzle blockages has resulted in different rubbing patterns. Analysis was undertaken to isolate the cause of this rubbing and to show a correlation between rubbing patterns and nozzle blockage configuration.

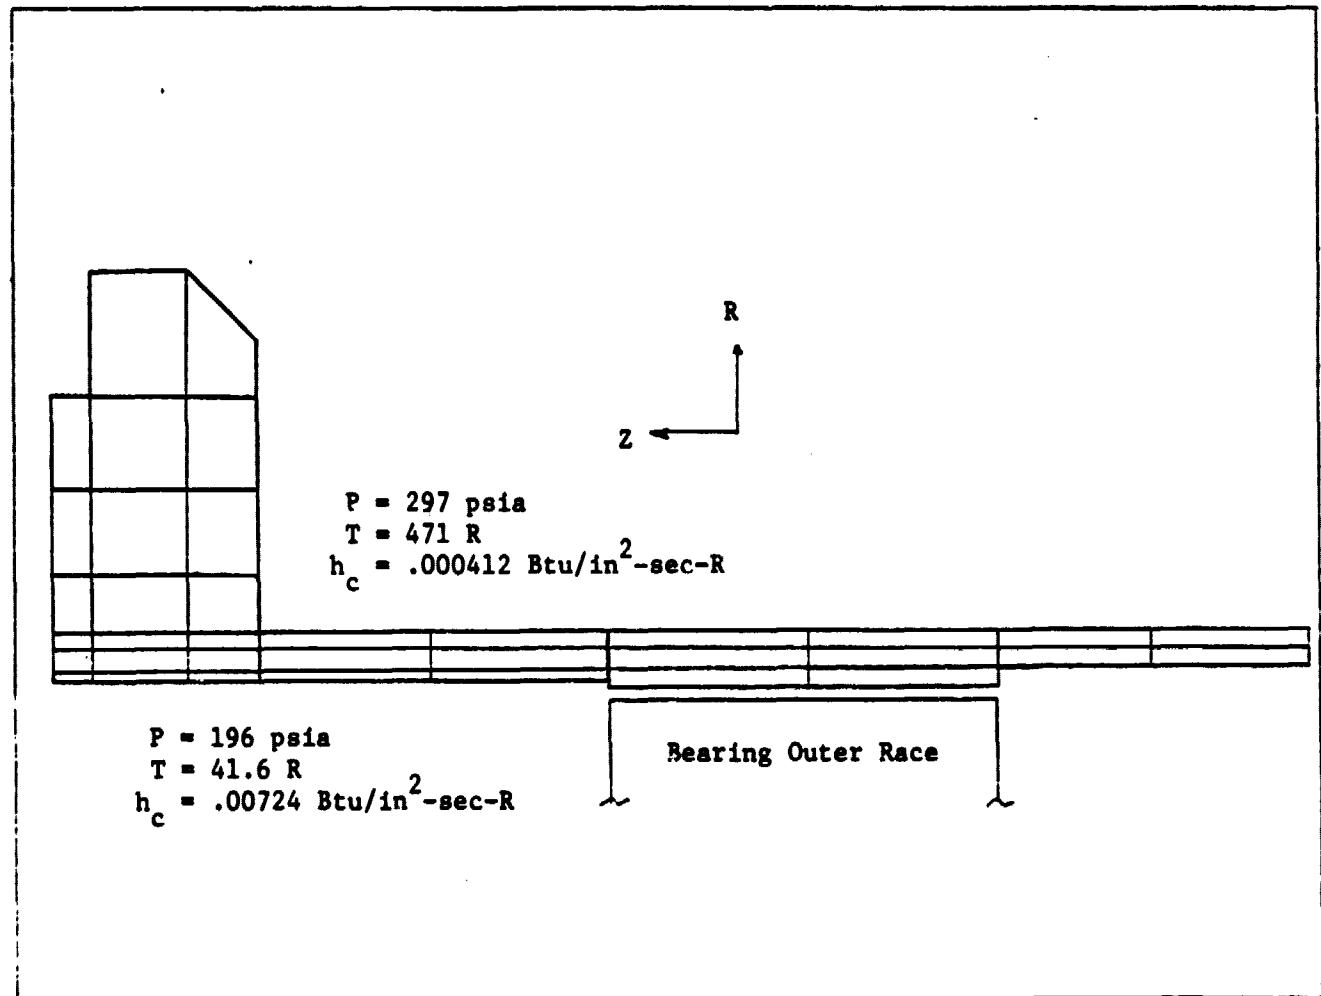
Fig. 2-2 LPFTP Bearing Carrier Environment

The thermal and pressure loads shown in Fig. 2-2 were applied to the NASTRAN bearing carrier model (Fig. 2-3) while the bearing race thermal deformation was calculated by hand. The resulting radial deformations were combined to produce a maximum radial clearance of .0038 in. Extrapolating the computed clearance axially to the labyrinth seal location yields a deflection of .0058 in.

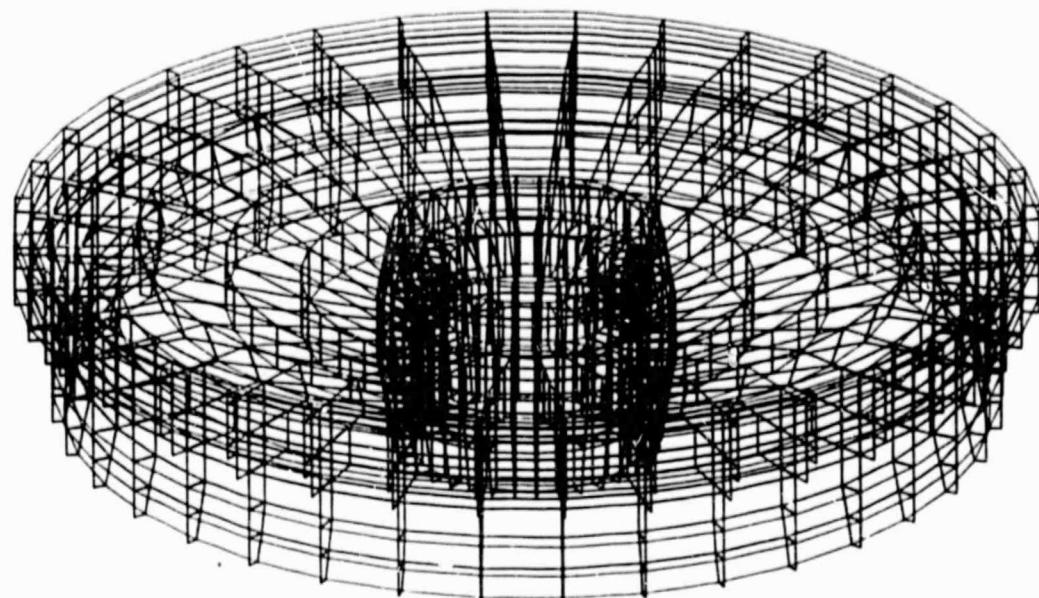
Fig. 2-4 LPFTP Turbine Wheel Model

The NASTRAN model of the turbine wheel and rotor (Fig. 2-4) was loaded with a centrifugal load simulating the operating speed and the constant pressure loads shown in Fig. 2-5. This loading resulted in a maximum outward radial deflection of .0022 in.

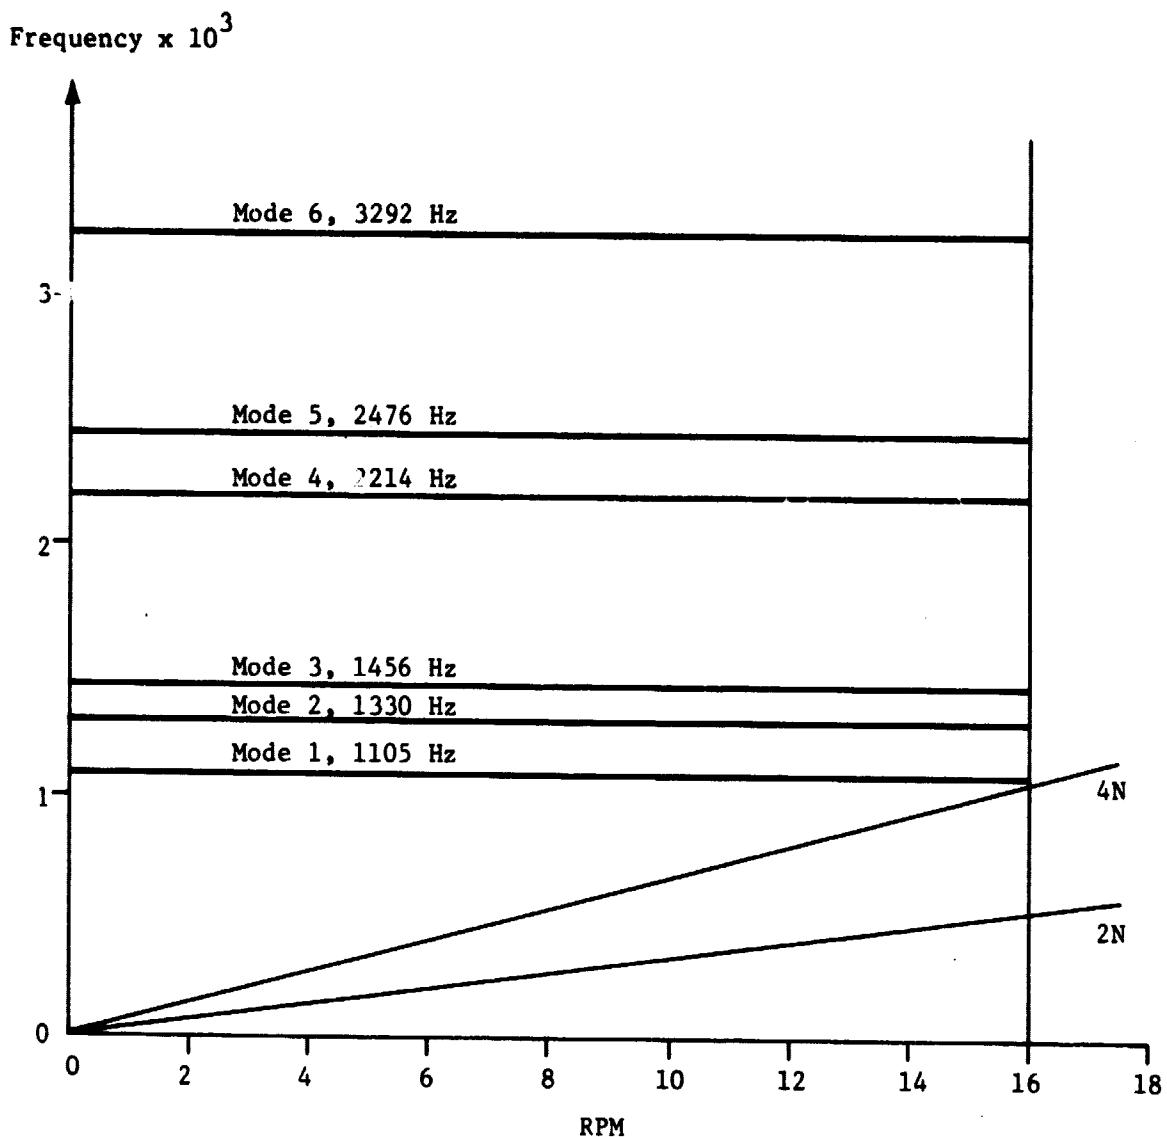
Fig. 2-12 LPFTP Turbine Disk - Campbell Diagram

The natural frequencies of the turbine wheel and rotors were extracted and the mode shapes plotted as shown in Figs. 2-6 through 2-11. The Campbell diagram of Fig. 12 shows a potential resonance at the first mode-fourth harmonic. It was speculated that this excitation could occur due to the passing in and out of blocked nozzle passage regions. However, the application of this dynamic load produced results that did not indicate the presence of a resonance condition. Output plots of labyrinth seal displacement versus turbine wheel rotational position shown in Figs. 2-13 and 2-14 indicate that the output response basically tracks the input load without the large displacements characteristic of a resonance. This leads to the conclusion that for both the symmetric and the non-symmetric blockage pattern, the dynamic loading produces only a forced response. The maximum magnitude of the response at the labyrinth seal is .0004 in. for the symmetric blockage and .0032 in. for the non-symmetric.

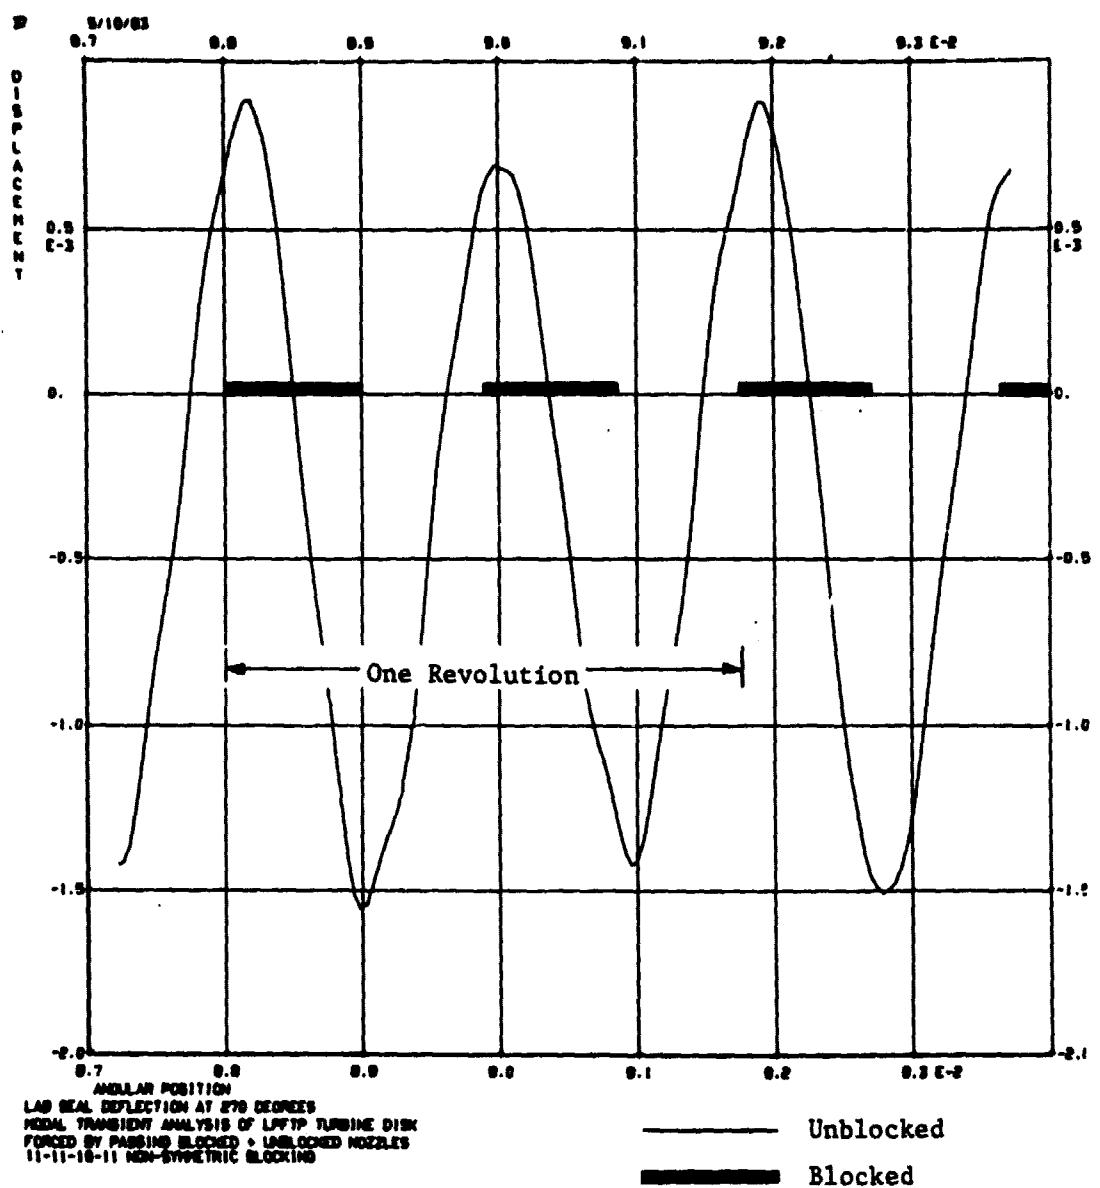
Fig. 2-13 Labyrinth Seal Deflection vs Rotation (Symmetric Blocking)

b. Symmetric Blockage
Labyrinth Seal Maximum Radial Deflection: .0004 in.

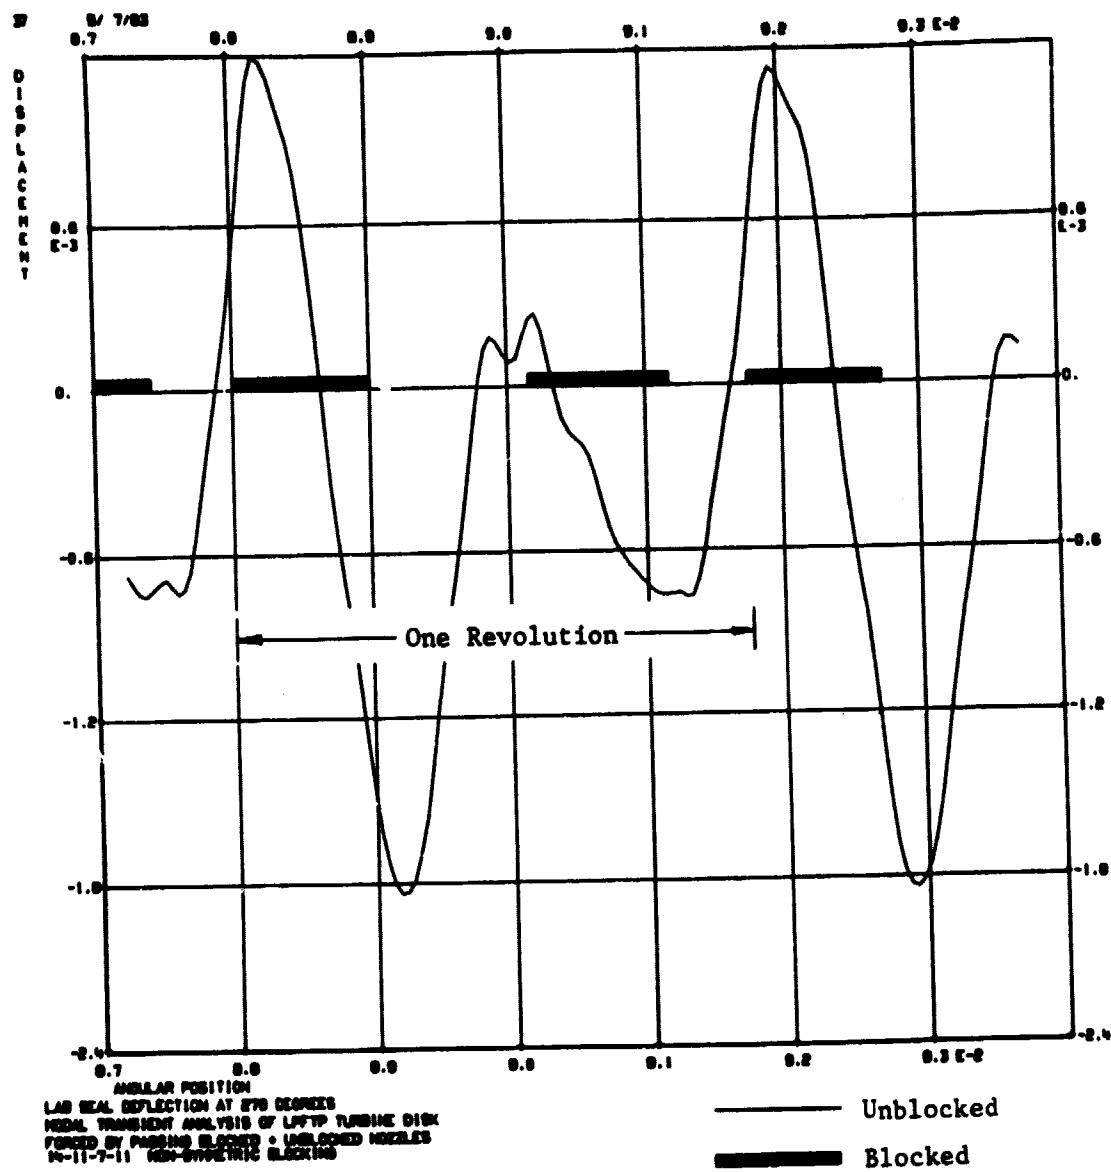
Fig. 2-14 Labyrinth Seal Deflection vs Rotation - Non-Symmetric Blocking

a. Non-Symmetric Blockage
Labyrinth Seal Maximum Radial Deflection: .0032 in.

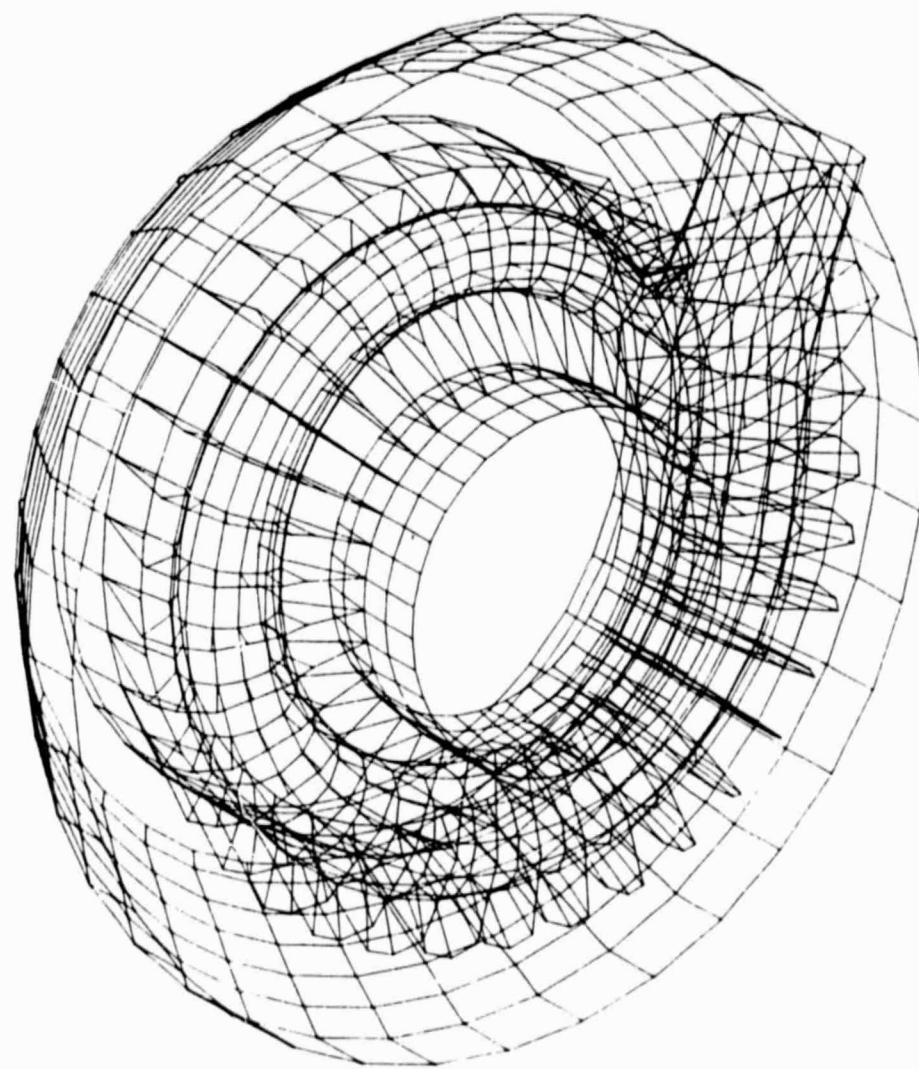
Fig. 2-15 LPFTP Inlet Manifold NASTRAN Model

NASTRAN models of the inlet manifold (Fig. 2-15) and nozzle assembly (Fig. 2-16) were built and merged (Fig. 2-17) to show the effects of the inlet manifold pressure distribution on the surface opposite the labyrinth seal. The pressure distribution described in Figs. 2-18 and 2-19 was applied and produced the radial deflections at the labyrinth seal area shown in Fig. 2-20. The deflections are inward (closing the labyrinth seal gap) and range from a minimum of .0001 in. to a maximum of .0015 in.

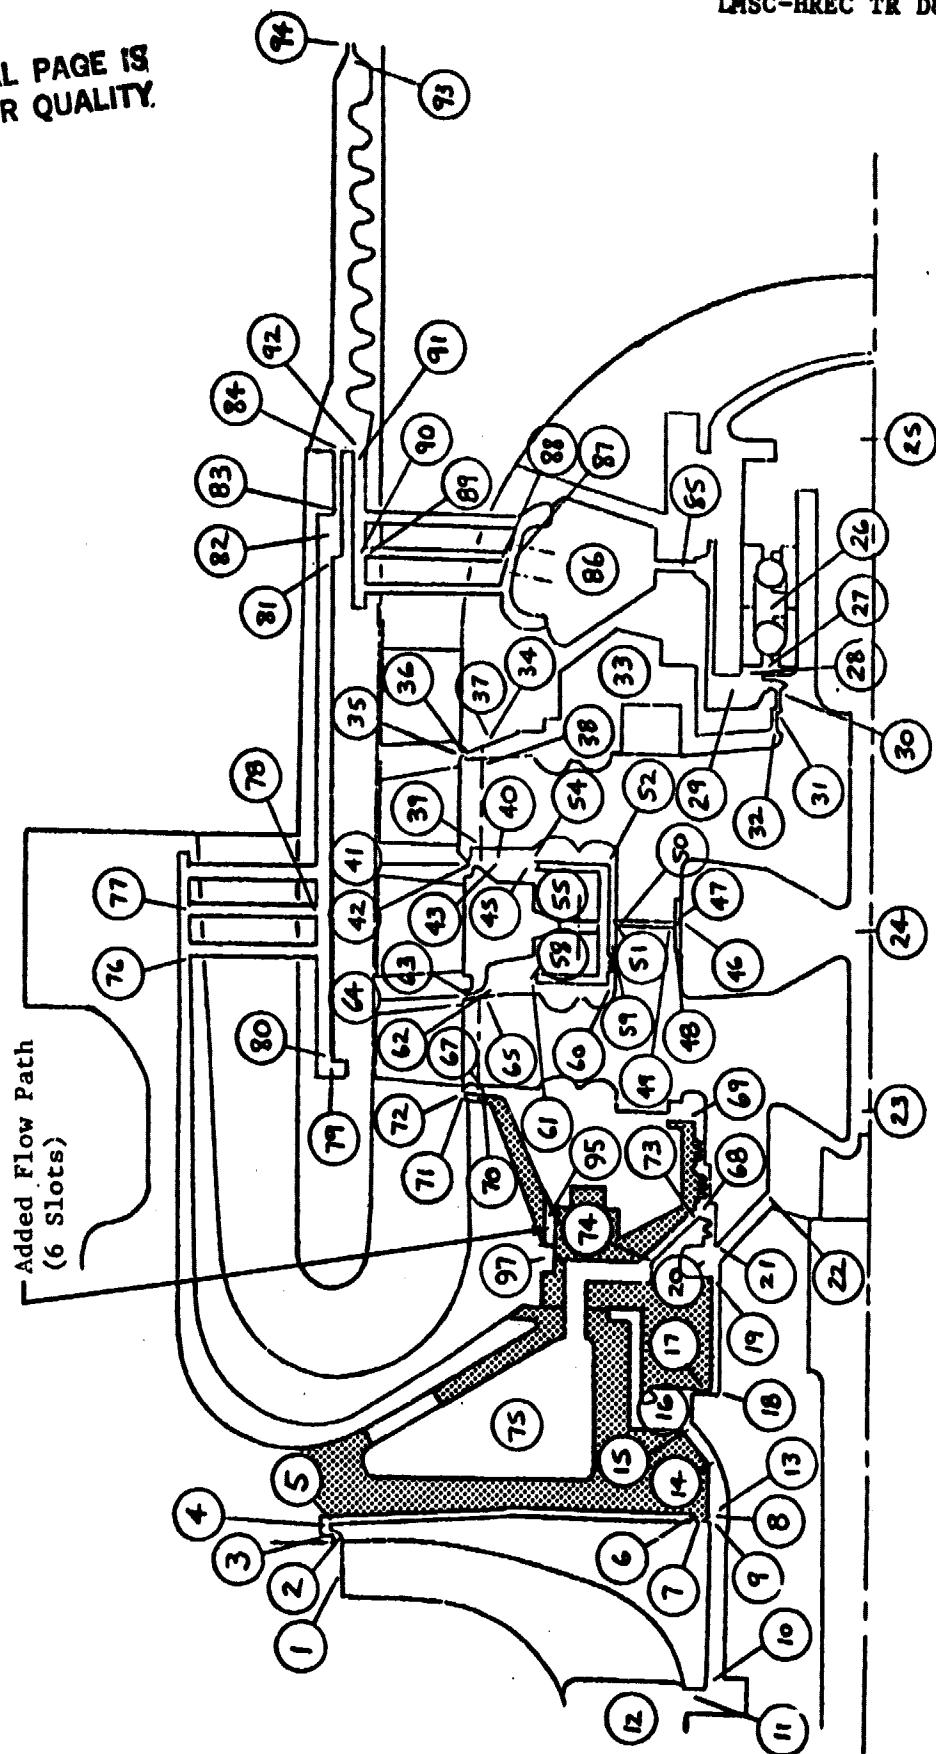
Table 3-1 HPFTP SECOND STAGE TURBINE DISK COOLANT MODIFICATION ANALYSIS
(Slot Area = .342 in²)

The HPFTP second stage turbine blades have experienced cracking in the aft shank region near the platform. One possible cause for these cracks is high thermal gradients resulting from the cold hydrogen coolant which flows up the back side of the disk. A modification to route the hydrogen coolant through six slots near the I.D. of the aft platform seal has been proposed. The HPFTP turbine coolant system flow model (Ref. 3.1) was modified to simulate this configuration. The model is shown schematically in Fig. 3-1. Flow rates and temperatures at several points of interest are compared with the nominal FPL case in Table 3-1.

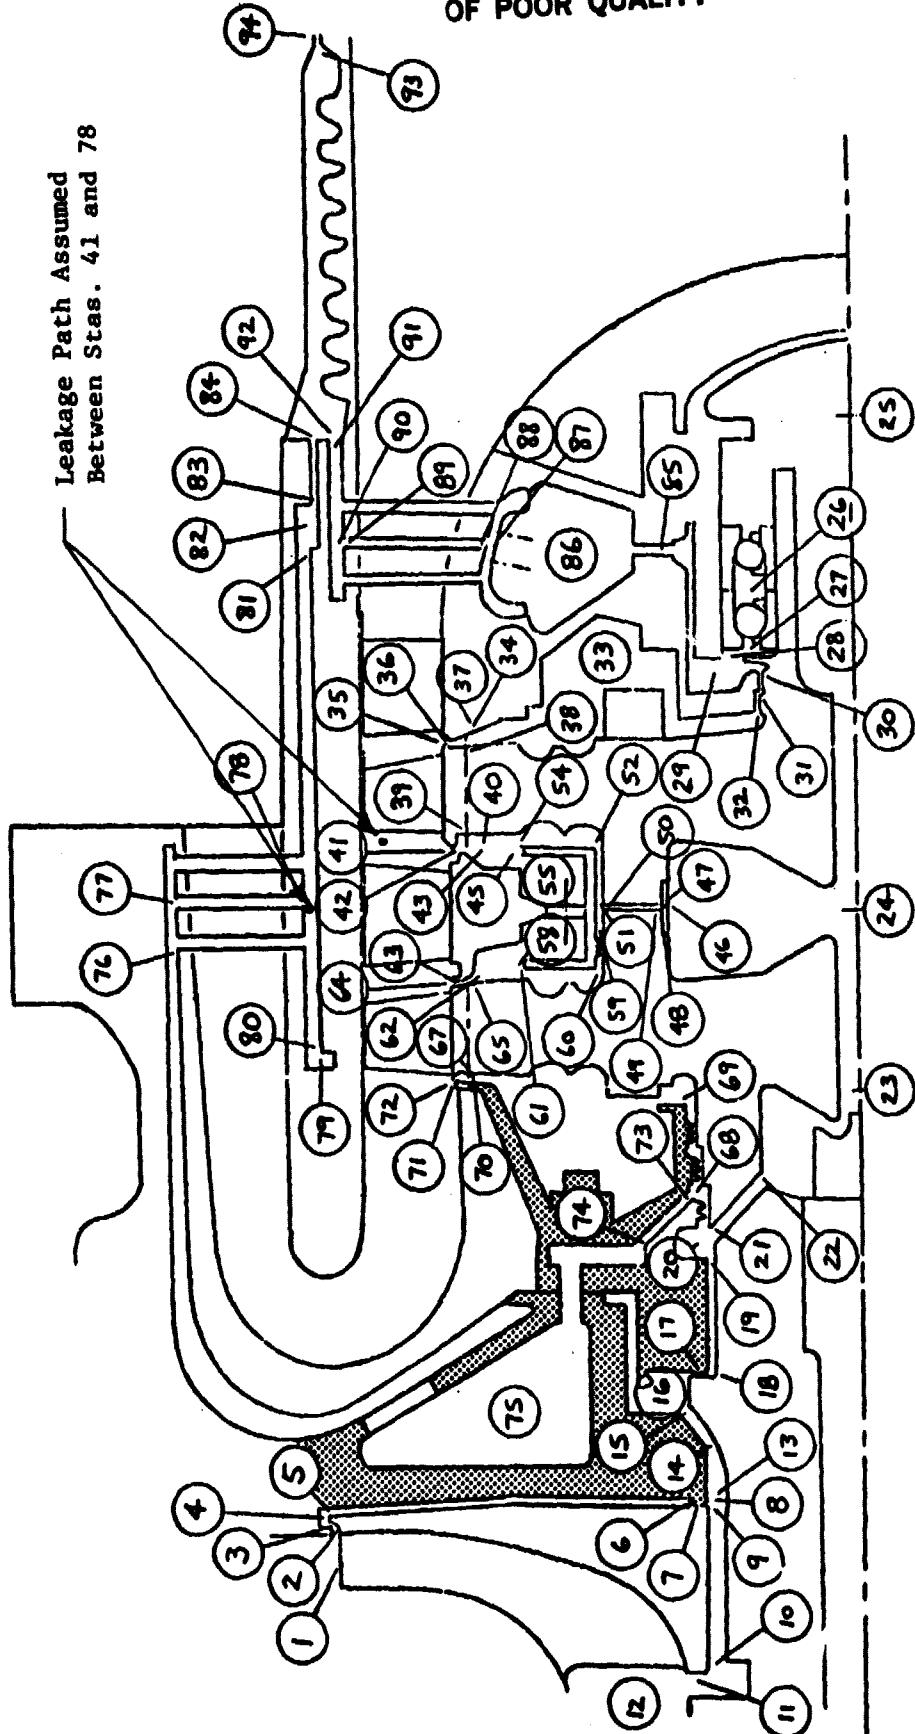
Fig. 3-2 HPFRP Turbine Coolant System Schematic with Turbine Housing
Leakage Modification

The HPFTP turbine coolant model was modified to simulate leakage of turbine gases into the coolant system downstream of the coolant liner. The leakage path is assumed to be cracks in the turbine housing downstream of the second stage rotor. The turbine coolant system (with the modification included) is shown in Fig. 3-2. Coolant liner pressure and leakage flow rate versus leakage area are shown in Fig. 3-3.

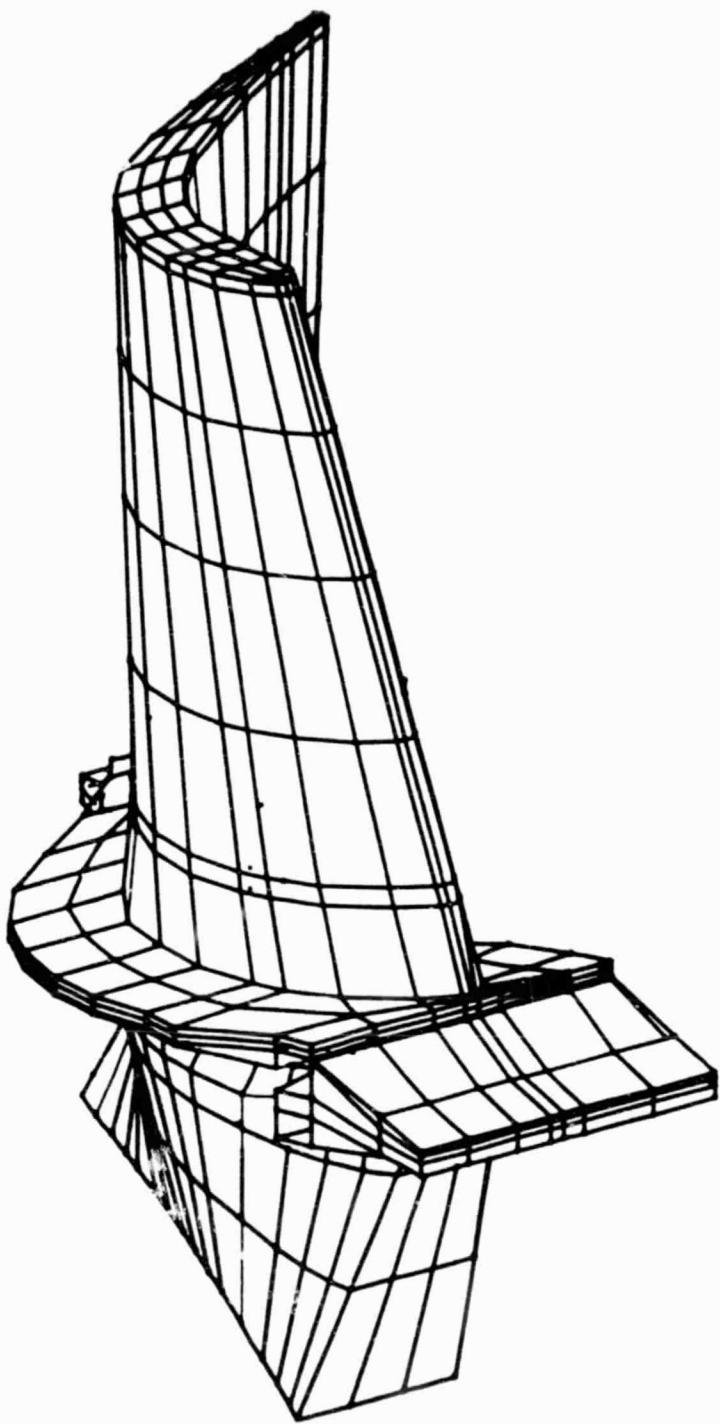
Fig. 4-1 HPFTP Second Stage Blade NASTRAN Model

The method of analysis was to alter a finite element model of the subject blade (drawn from our existing library of models) by introducing a crack of varying length in the area of interest. An overall view of the model is shown in Fig. 4-1. A section of the critical area is shown in Fig. 4-2, with the discrete crack length investigated.

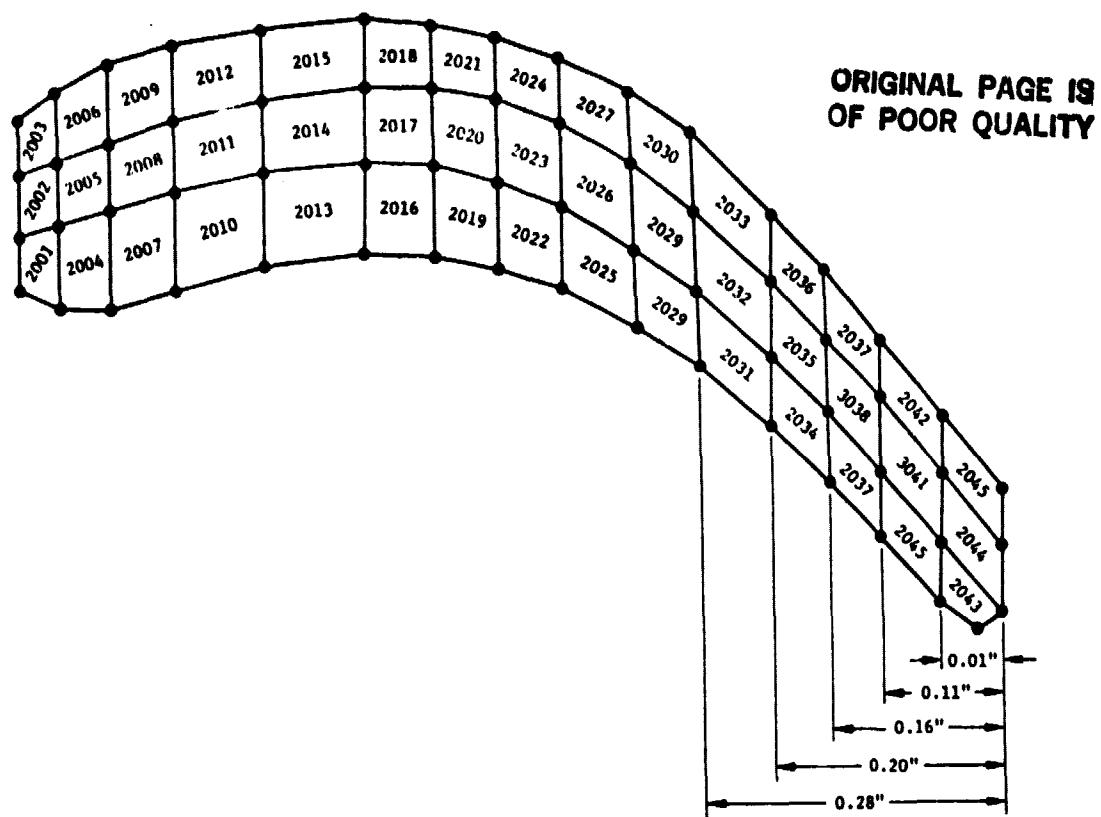
Fig. 4-2 Critical Area and Crack Lengths

The objective of this study was to relate a statistical margin of safety to flow size in the second stage turbine blade of the HPFTP. The flow was defined as a crack in the aft edge of the blade shank, immediately under the platform. This crack was in the flow direction, through the shank, and of a variable length. The load conditions were power bending and centrifugal forces at 104 percent RPL. Thermal loads are not included, but thermal degradation of material properties were accounted for.

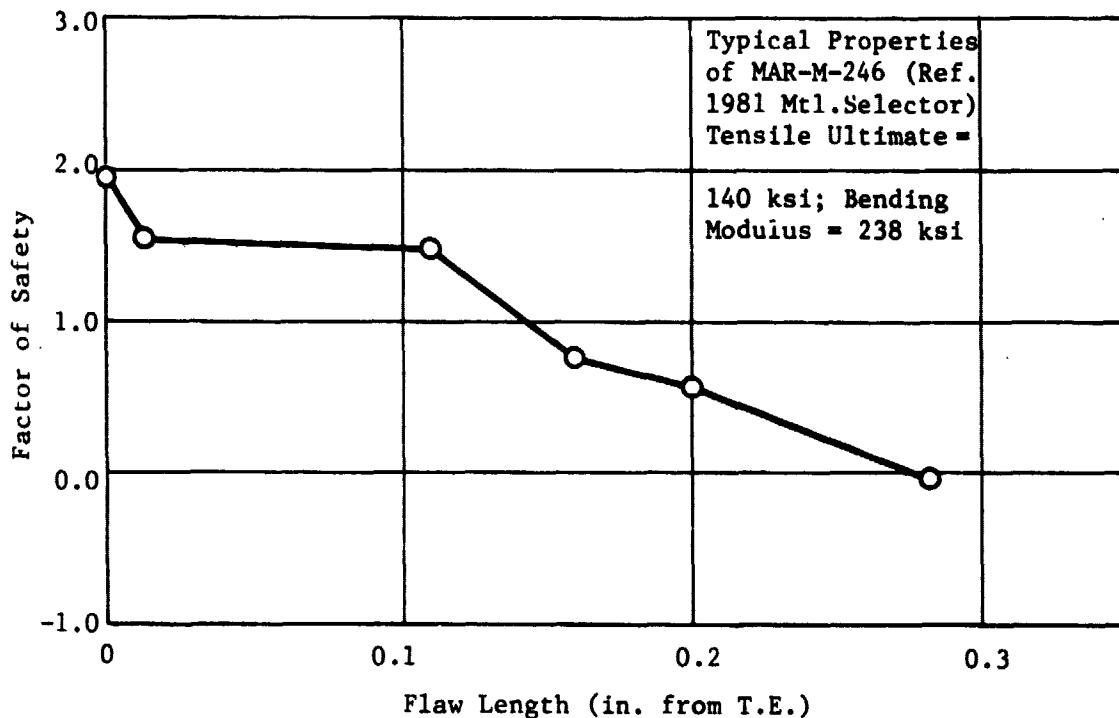
Fig. 4-3 Factor of Safety vs Crack Length HPFTP
Second Stage Blade Shank at 104% RPL

The resulting margins of safety are summarized in Table 4-1 and are presented graphically in Fig. 4-3.

Crack Length (in.)	Tension Stress (ksi)	Bending Stress (ksi)	Factor of Safety
0.0	37.2	16.7	+2.05
0.01	41.9	21.3	+1.56
0.11	42.9	22.2	+1.50
0.16	57.2	36.6	+0.78
0.20	64.0	44.0	+0.36
0.28	94.9	78.1	-0.01

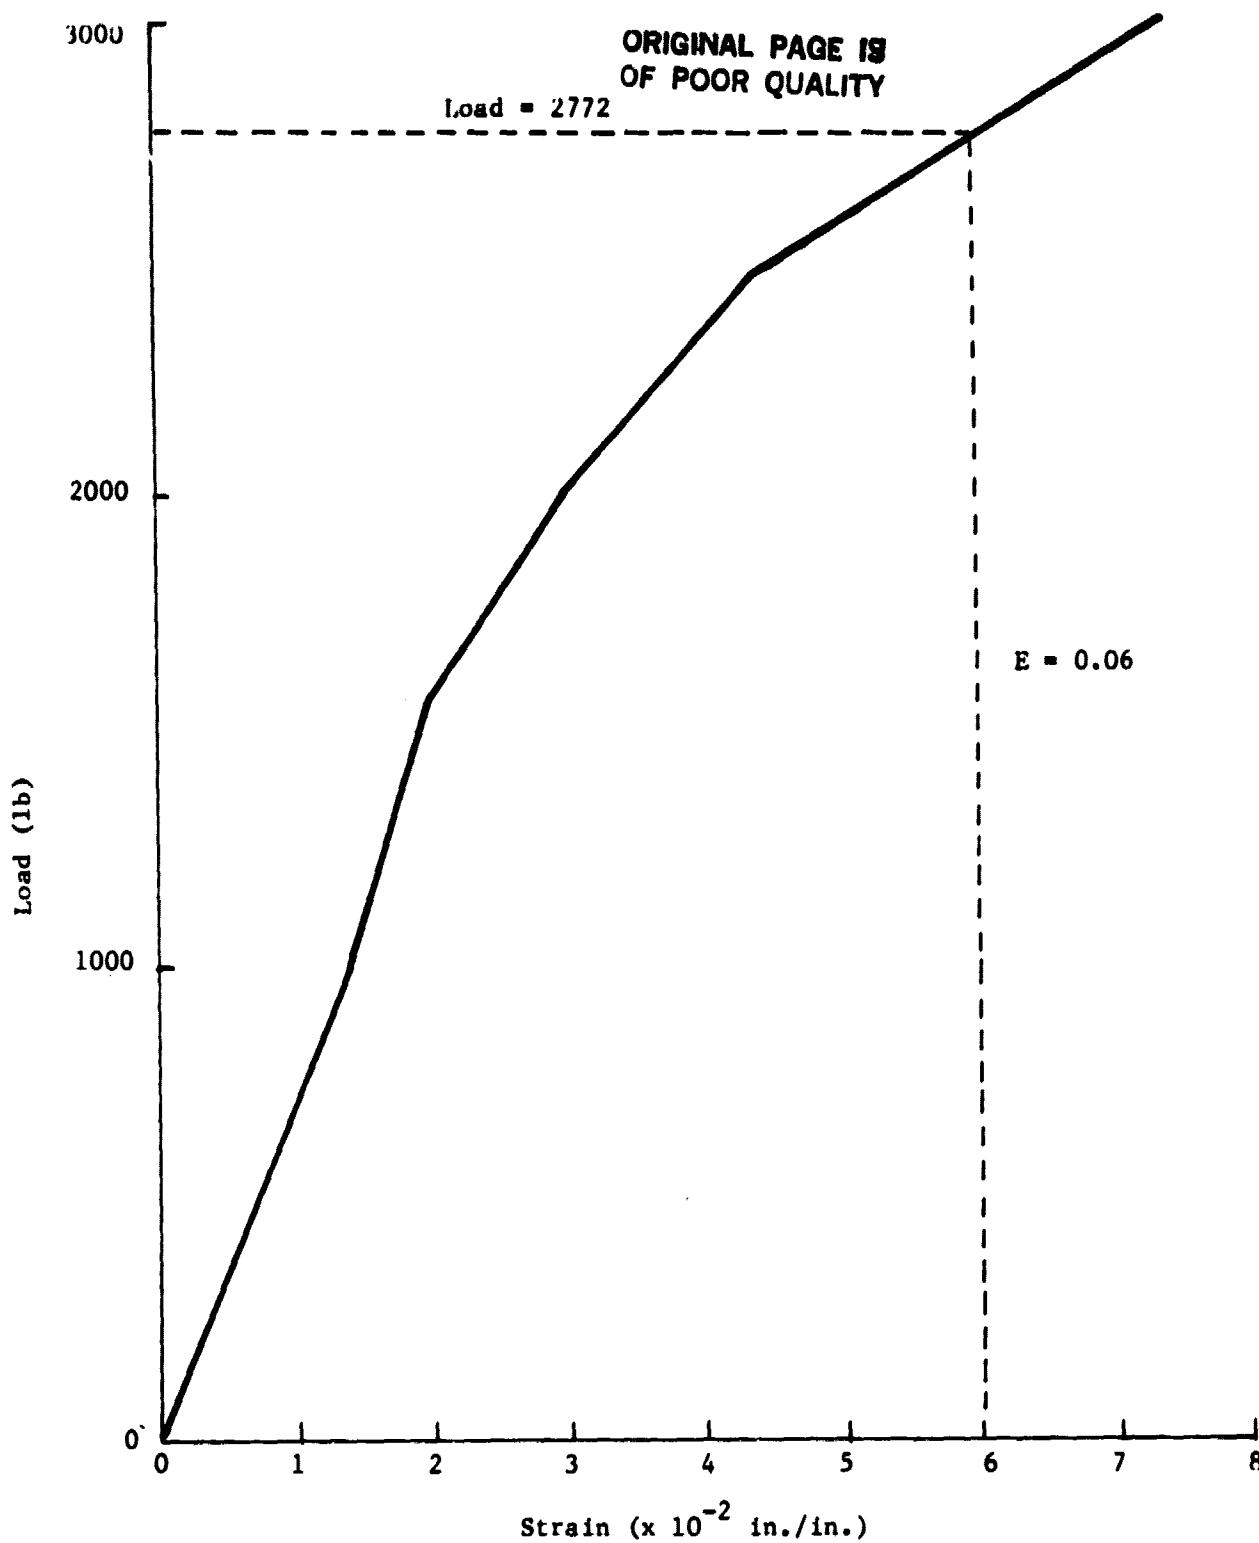
Fig. 5-1 Maximum Strain vs Applied Load

The BOPACE plastic analysis program was used in the computation of the strain energy term, U. The failure criteria of $\epsilon = 0.06$ is satisfied with a leading edge load of 2772 pounds (Fig. 5-1) which has a corresponding deflection of 0.198 in. at the point of application (Fig. 5-2). The strain energy is calculated by finding the area under the load deflection curve (Fig. 5-2) which yields:
